VAPORIX Diagnostics Summary

Documentation
for facilitating the troubleshooting procedure
in vapour recovery systems at filling stations
equipped with an automatic monitoring system of the type
VAPORIX.

Edition: 02/2011
Version: 1
Art. no.: 207155

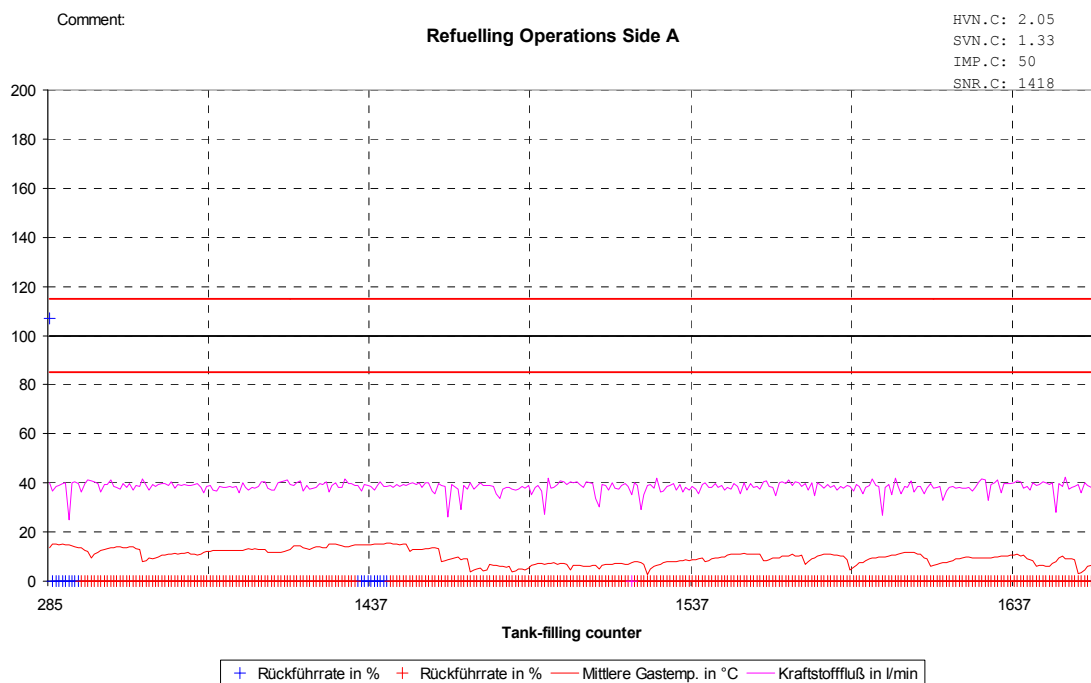
- Pump defective
- Thermal circuit breaker of the pump has tripped
- V-belt torn or jumped off

- Vapour recovery rate is very low or equal to zero as shown in Figure 4.

Figure 4: Total failure in the vapour recovery with 0% recovery rate. The colour of the crosses changes from blue to red as soon as the error counter reaches the value 10. At refuelling operation number 1433 a reset was exerted but without repairing the system. Therefore the colour of the crosses were blue for ten refuellings and then change to red again.

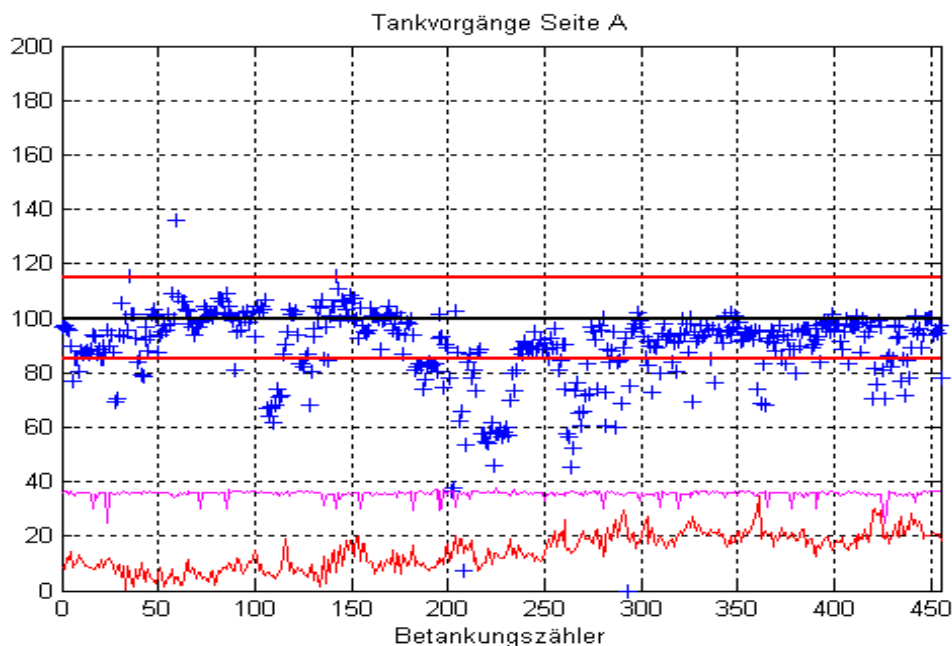
- Metal chips or other dirt particles in the proportional valve
- Wear

In some cases, a balancing operation can still be carried out despite the fault. However, the adjustment curves created as a result are incorrect. The measured recovery rates vary considerably and can be much too high or much too low. In case the defect did not occur until after the adjustment procedure, the history data will be as shown in Figure 5.

Figure 5: Dispenser point with sticking proportional valve. The x axis represents the refuelling counter, the blue crosses the recovery rate in percent, red line the gas temperature and the magenta line the average fuel flow speed.

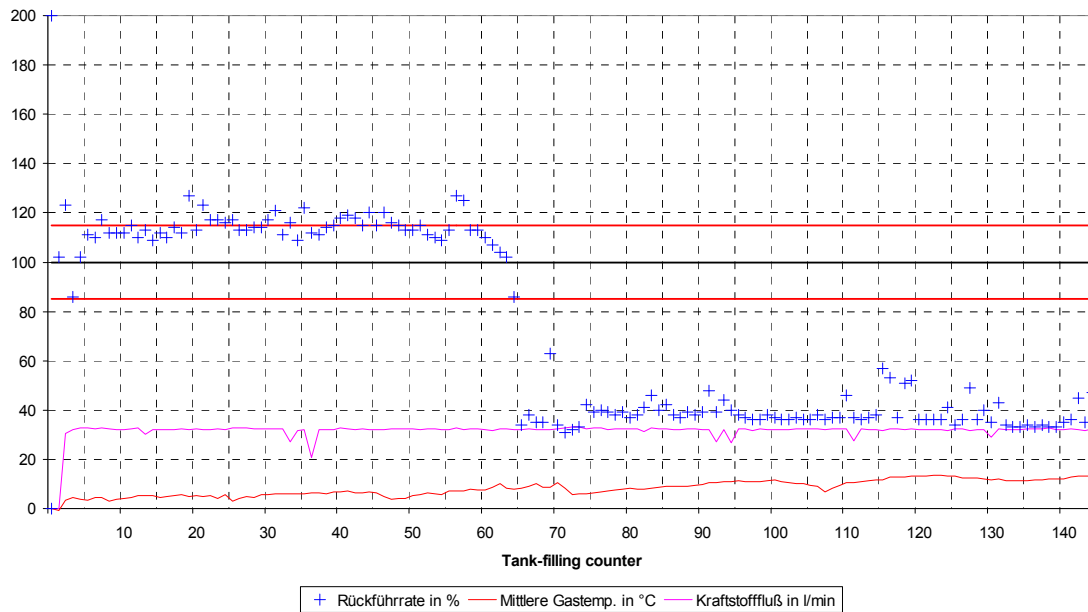
- 1) A leak (e.g. crack in the pipe or loose screw joint) occurs downstream from the sensor of the automatic monitoring system, in a time after the vapour recovery system was correctly adjusted without any leaks. In that case, the measurement value of the automatic monitoring system drops as shown in Figure 6. A dry measurement with a diaphragm flow meter at the nozzle would exhibit the same result.

Figure 6: Example according to case 1. Refuelling history of a refuelling point, which during refuelling operation 65, a crack occurred in the flexible corrugated pipe between the sensor of the automatic monitoring system and the vapour pump. Due to the suction of additional air, the recovery rate fell to approx. 40 %.

- Leak test and sealing of the respective locations

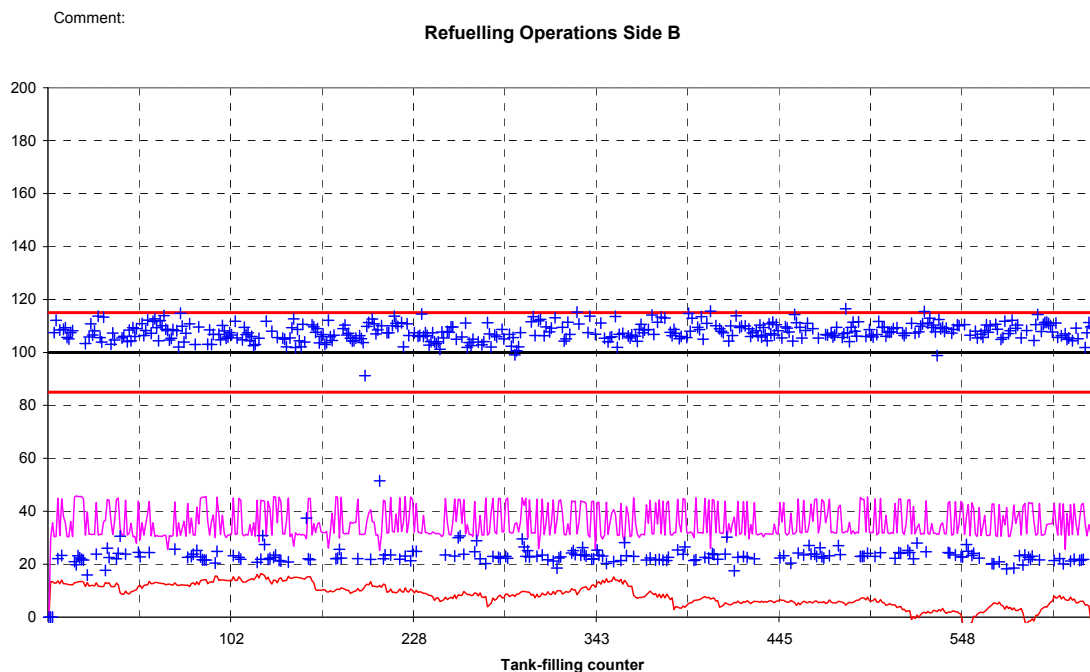
1. The defect did not already exist during the dry balancing operation of the vapour recovery or the balancing operation was carried out on a properly open nozzle. The recovery rates measured by the automatic monitoring system after the defect occurred are reduced for this hose. A dry simulation on defect nozzle would also show a reduced vapour flow. In Figure 7 is shown that the recovery rate is within the tolerance for the correct working hoses, but a reduced recovery rate is observed for the affected hose.

Figure 7: MPD with one incompletely opening Open/Close valve. Some of the refuelling operations exhibit a recovery rate of only 25%.

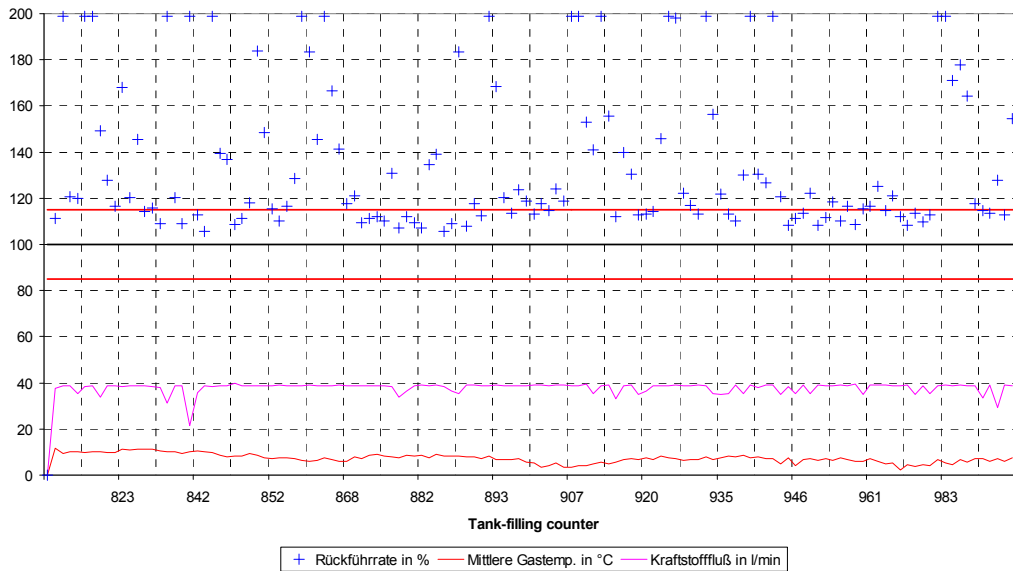
- O-rings or hoses leaky
- The fuel flow speed is too high
- Shutdown speed of the nozzle is too slow
- Unfavourably shaped fuel tank filler neck geometries of individual vehicle types
- The outlet pipe of the nozzle can be deformed as a result of falling down or a vehicle driving off

Figure 8: Occurrence of condensate in the recovery tubing. The recovery rate is frequently approximately up to 199%, which is the maximum value for the output in the case of existing pulses, as opposed to 200% in the case of non-existing pulses.

- The system should not be readjusted as long as liquid is still in the tubing since otherwise – especially in the case of vapour recovery systems with a high k-factor – the recovery rate will be too high.
- Installation of new seals
- In the case of new dispensers or new seals, wait a few days until the sealing have swollen up.
- Replacing the hoses, if the cause cannot be found elsewhere
- Reduction of the fuel flow speed to values ≤ 40 l/min
- Replacing the nozzle by one with a more sensitive switch-off characteristic, if necessary, adjustment of the sensitivity
- Replacing the outlet pipe of the nozzles

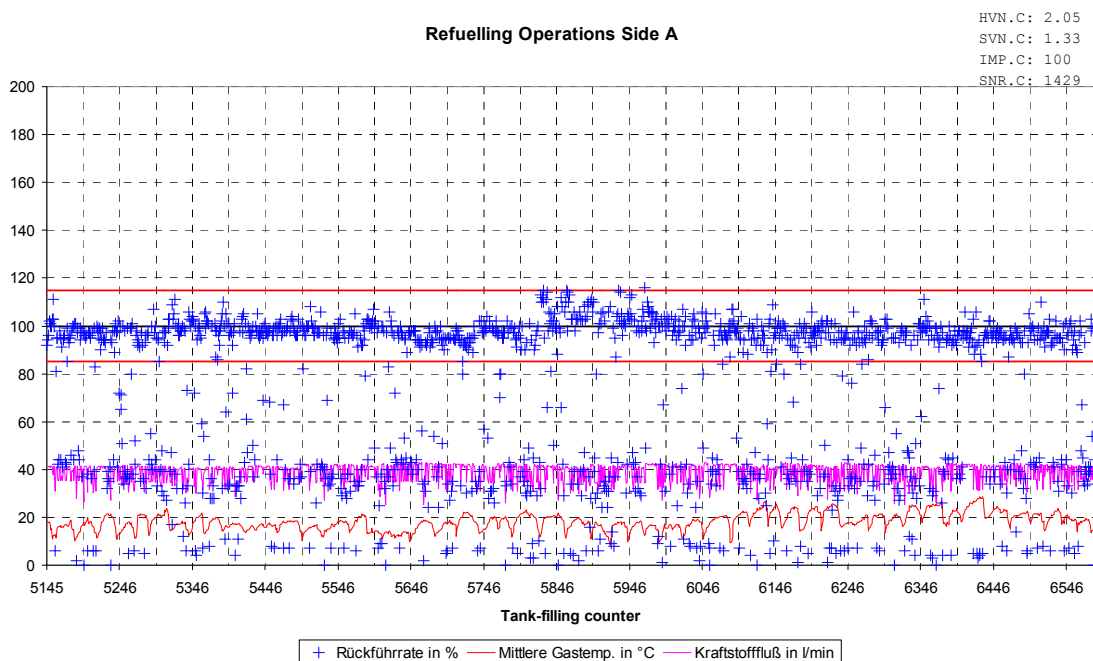
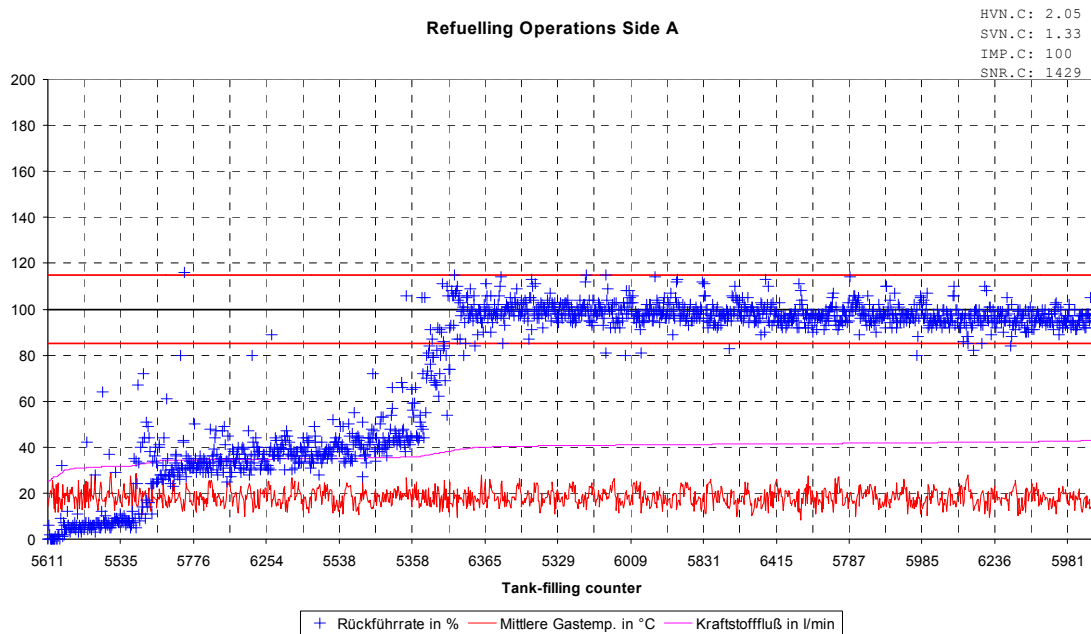
- Random values from before are then used for the control system. The recovery rates can be far apart depending on the fuel flow rate in each case (see Figure 9).
- A dry measurement reproduces the measurement values of the automatic monitoring system.
- Perform dry measurements with a diaphragm flow meter for different pump flow speeds.
- In order to detect possible causes sort the data with respect to the fuel flow speed. The result is shown in figure 10. It reveals immediately that the recovery rate is strongly dependent on the fuel flow speed. This indicates a faulty adjustment of the vapour recovery system.

Figure 9: Data of dispenser point with frequently extremely reduced recovery rate. The exact cause cannot be detected in the standard data representation.

Figure 10: The same data set as in Figure 9 sorted according to the fuel flow speed (magenta curve). In the case of fuel flow speed below 40 l/min, the recovery rate declines substantially. The cause is a fault in the adjustment data.

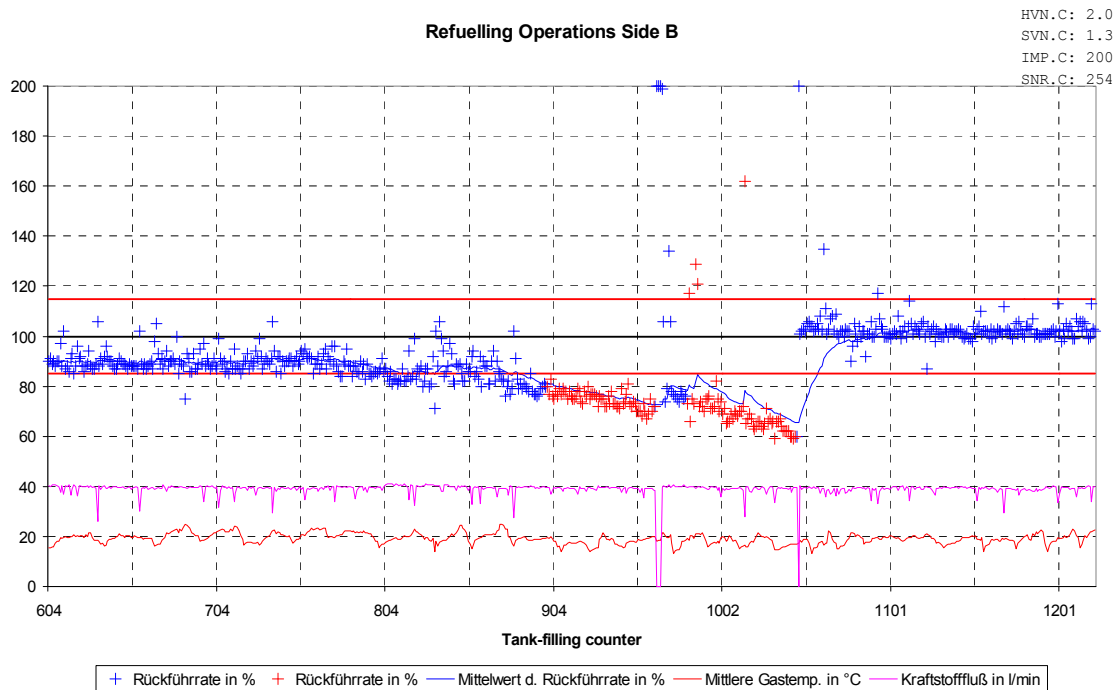
- Due to the advanced wear of the vapour pump, the pumping performance decreases more and more.

- The recovery rate drops more and more.
- Balancing operations provide only short-term improvement or no improvement at all.
- Dry measurements with a diaphragm flow meter show the same result.

Figure 11: The recovery rate of the vapour recovery decreases more and more with time. The readjustment procedure at refuelling operation #965 only provides slight improvement. Replacing the pump during refuelling operation #1046 finally eliminates the cause.

- Repair or replace the vapour pump

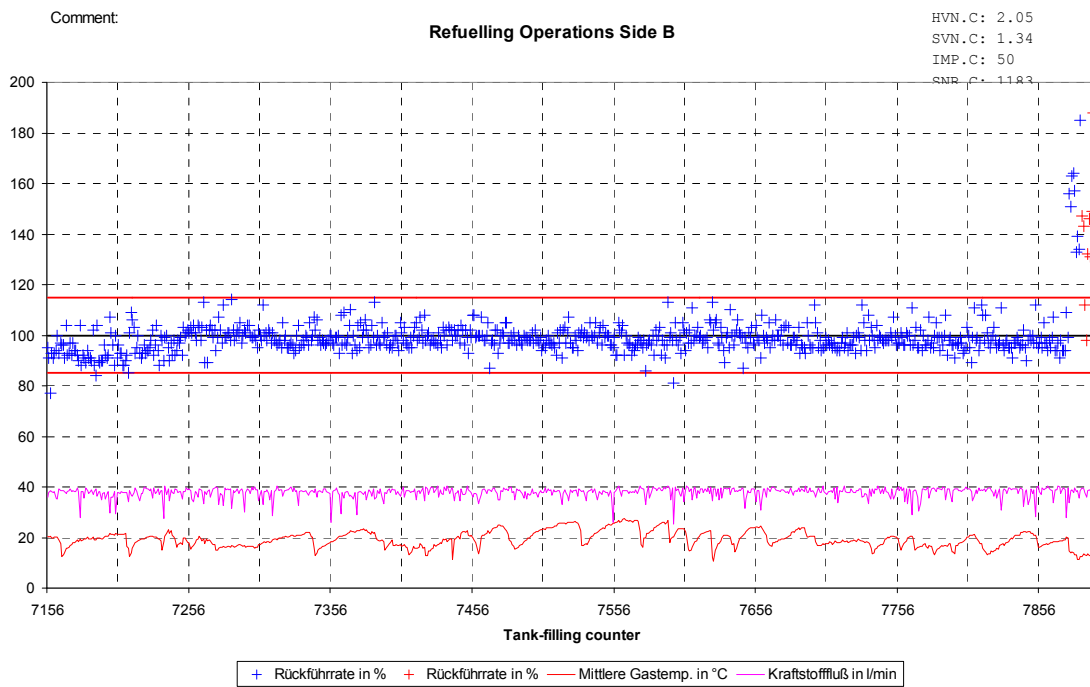
- When attempting to leave the filling station without removing the nozzle from the fuel tank filler neck of the vehicle, the nozzle and/or the hose might be damaged. In the example shown in Figure 12, only the nozzle was replaced/repared but a tear in the hose remained undiscovered, and therefore VAPORIX triggered an alarm after the dispenser was put into service again.

- The status bit for liquid recovery (10-0000) has been set.

Figure 12: The recovery rate of the vapour recovery increases suddenly and apparently uncontrolled during refuelling operation #7877.

- Replace all the adversely affected components.

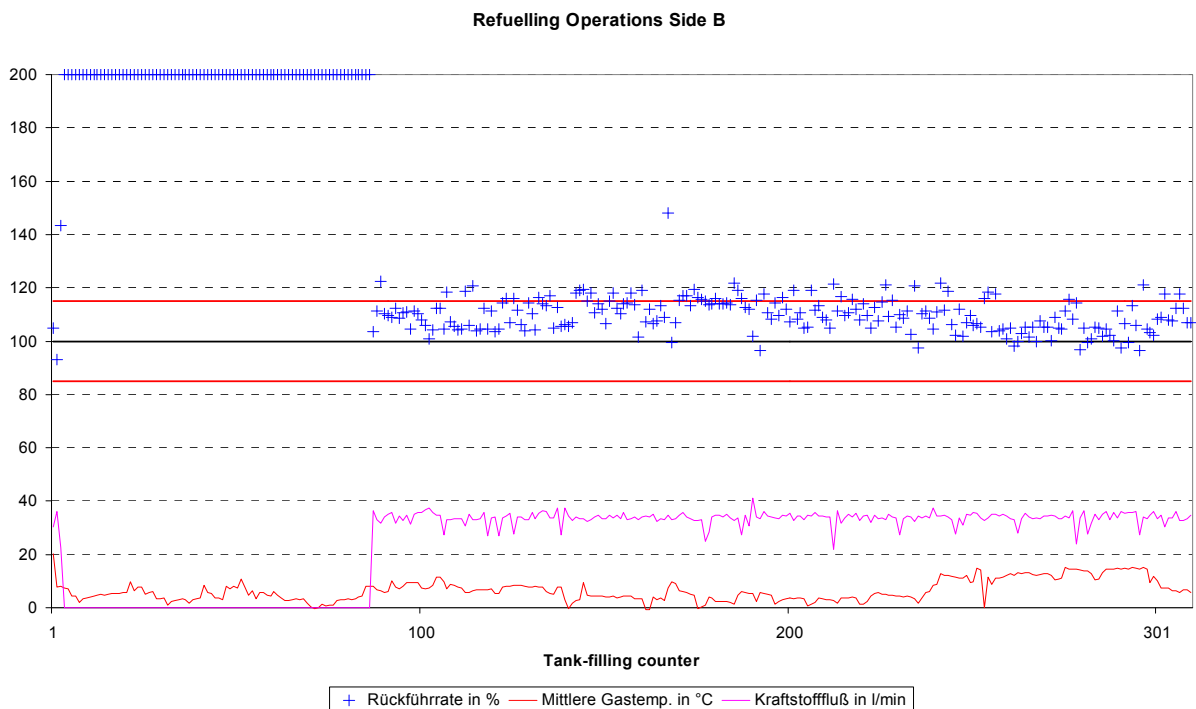
- In the course of connecting the pulse inputs, the polarity was connected incorrectly and this is why the fuel flow speed cannot be determined by VAPORIX-Control.
- By flashing very quickly, the LED on VAPORIX-Control indicates vapour flow without pulses.
- Refuelling operations with vapour flow without pulses are included in the history data; the vapour pumping rate is indicated with 200%.

Figure 13: The connecting cable for the fuel pulses is not correctly attached on the VAPORIX-Control system, the output recovery rate is indicated to 200 % and the fuel flow speed is 0 l/min. During refuelling operation 87, the connection fault was rectified.

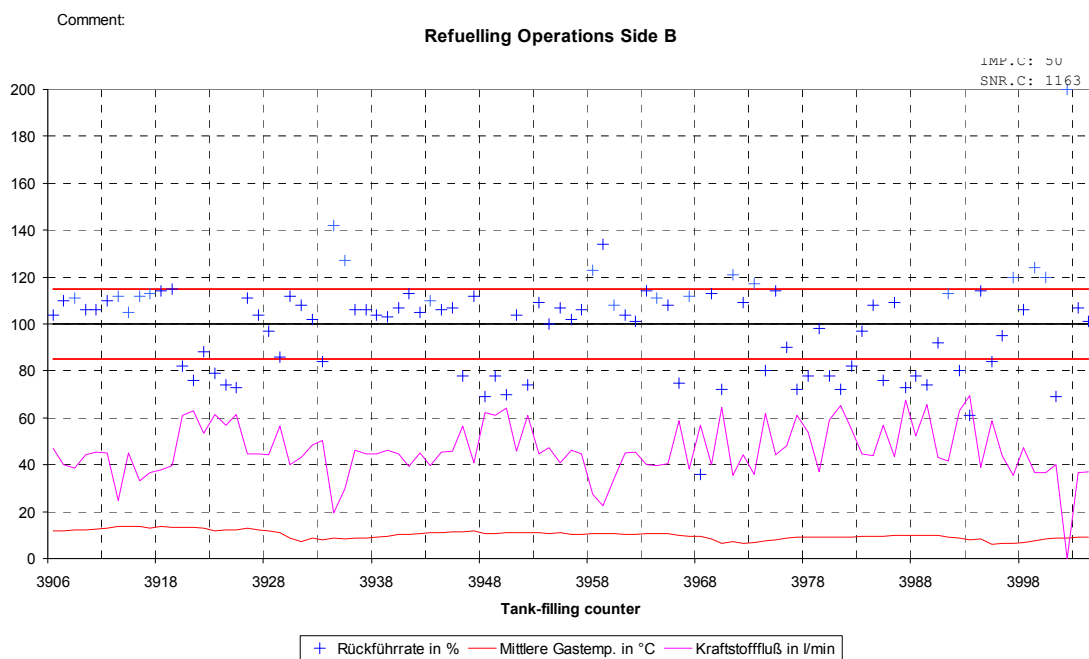
- Extreme interference couples into the pulse cables, which causes to an increased pulse rate at the inputs of the VAPORIX-Control. Accordingly, the evaluated fuel flow speed appeared too high and the recovery rate too low.

Figure 14: The output fuel pumping rate is partially above 60 l/min and exhibits an unusual scatter.

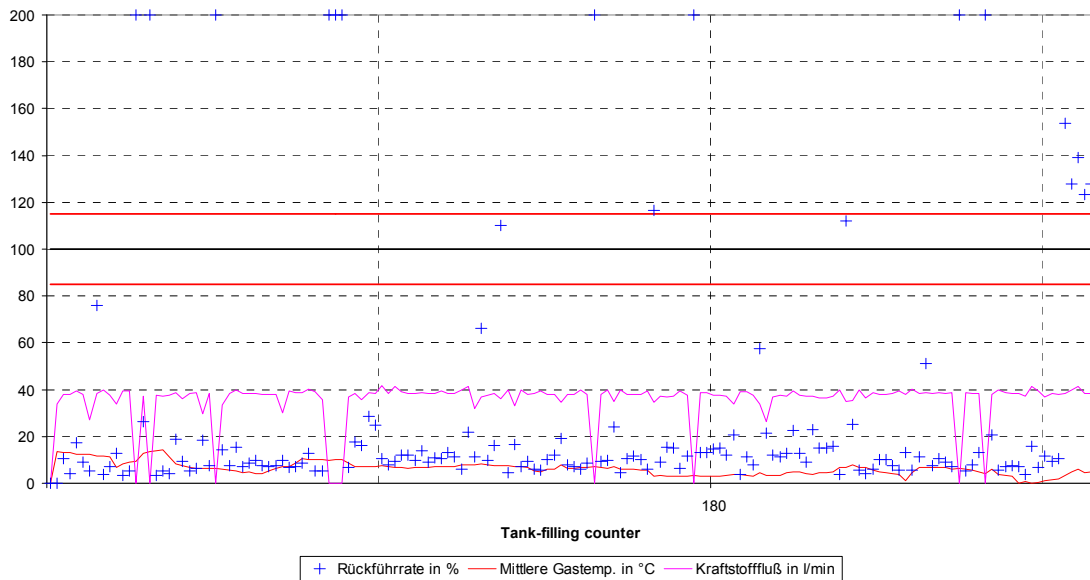
Figure 15: Refuelling operation on side A of an MPD with opposite-side control of the vapour recovery. The apparent recovery rate of approx. 10% is caused by pulsation of the vapour recovery system running on the other side.

Table 4: The history entries from figure 15 with recovery rates greater than 50%. By comparing the date and time (e.g. 16:22 on 8.11.) with the entries of side B shown in Table 5 it can be seen that these recovery rates frequently occur during simultaneous refuelling operations on both sides. If the respective refuelling operation on the other side is missing, it took only a short period of time (< 20 sec) and was therefore not included in the history.

- Exchanging the control cables of the vapour recovery system

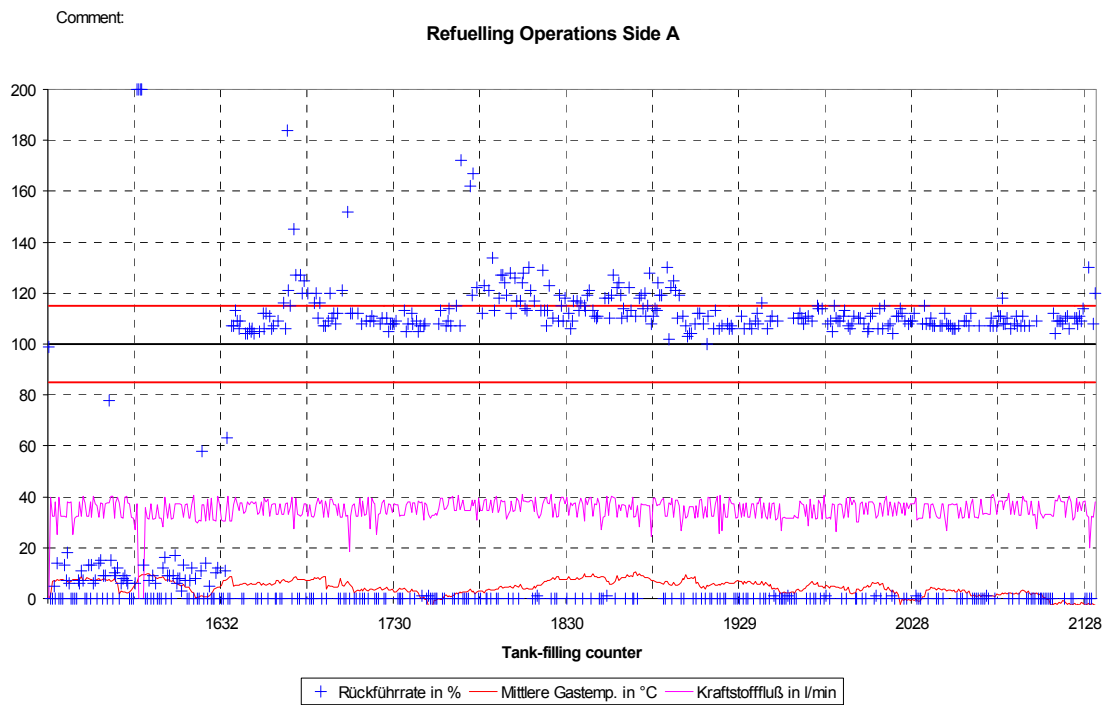
Figure 16: The same dispenser point as shown in after exchanging the cables of the vapour recovery system. During refuelling operation 1890, the system was adjusted. The pulses representing diesel refuellings are still present.

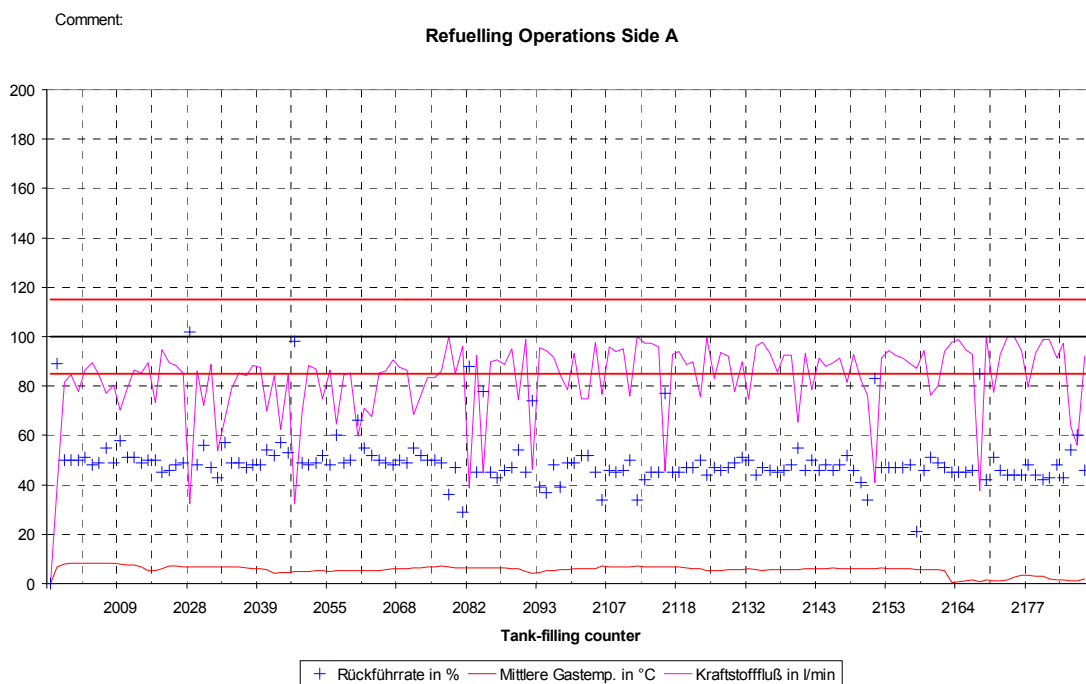
- If the impulse rate is set too high on the automatic monitoring system, the volumetric flow of fuel will be interpreted too low and the associated – correct volumetric flow of vapour – too high.
- If the impulse rate is set too low on the automatic monitoring system, the volumetric flow of fuel will be interpreted too high and the associated – correct volumetric flow of vapour – too low.
- A dry measurement with a bellows flow meter would provide correct values in both cases.

Figure 17: The fuel-pumping rate that is output by the automatic monitoring system goes up to 100 l/min, and the recovery rate is about 50%.

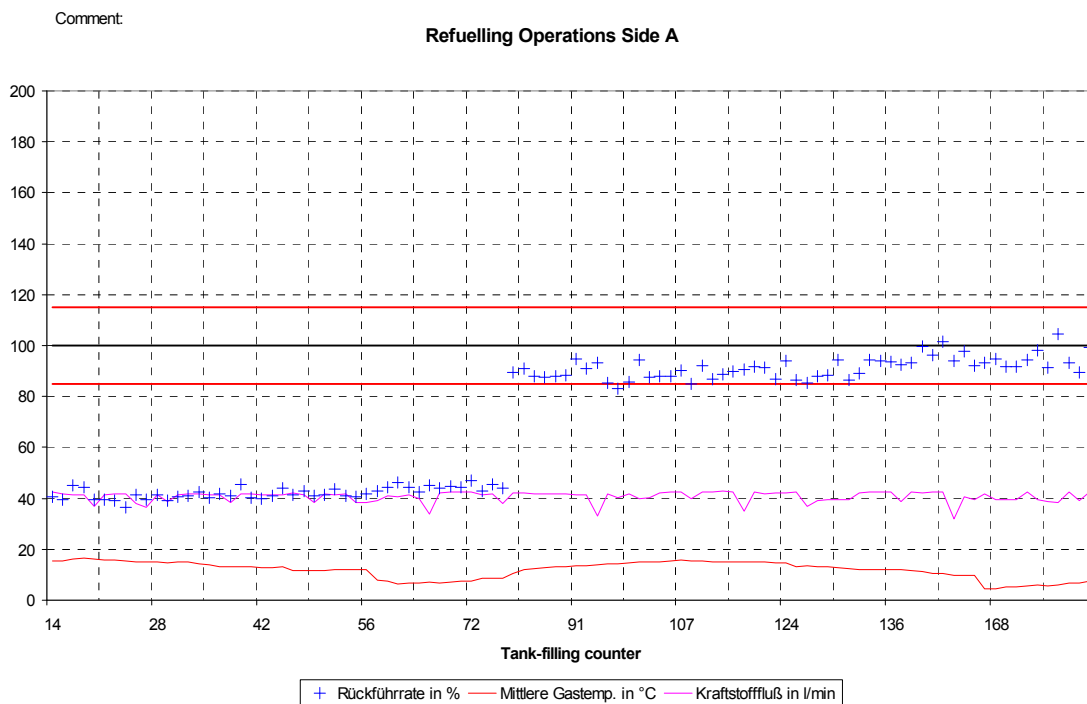
- If the impulse rate is set too high in the vapour recovery control system, the volumetric flow of fuel will be interpreted too low and the vapour recovery system will not be pumping enough. A wet measurement with a diaphragm flow meter would also provide values that are too low. A dry measurement would provide apparently correct values.

Figure 18: The refuelling operations 14...75 were carried out at an impulse rate set too high for the vapour recovery system. As a result, the vapour recovery ran with only half the pumping performance.

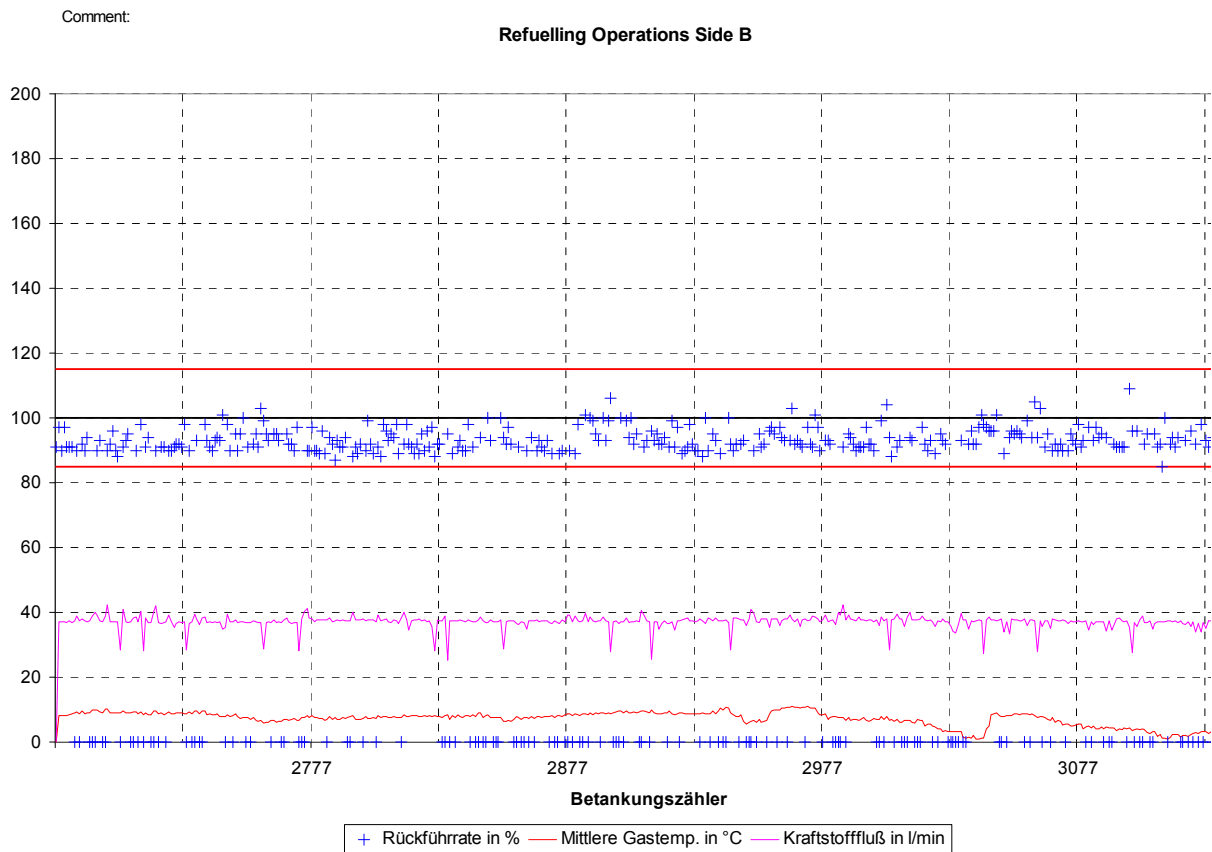
- Faulty configuration of the dispenser or missing interface for inhibiting the diesel pulses

- The diesel refuelling operations appear in the history data. If the vapour recovery is not running simultaneously, it is equal to zero, but if it is running, this can result in a small measurement value. The probability for the occurrence of these refuelling operations is approx. 30%. An alarm would be triggered only if 10 diesel tank-filling operations were to occur in succession.

Figure 19: Diesel pulses are not hidden. In case more than 10 diesel tank-filling operations are carried out in succession, an alarm is triggered.

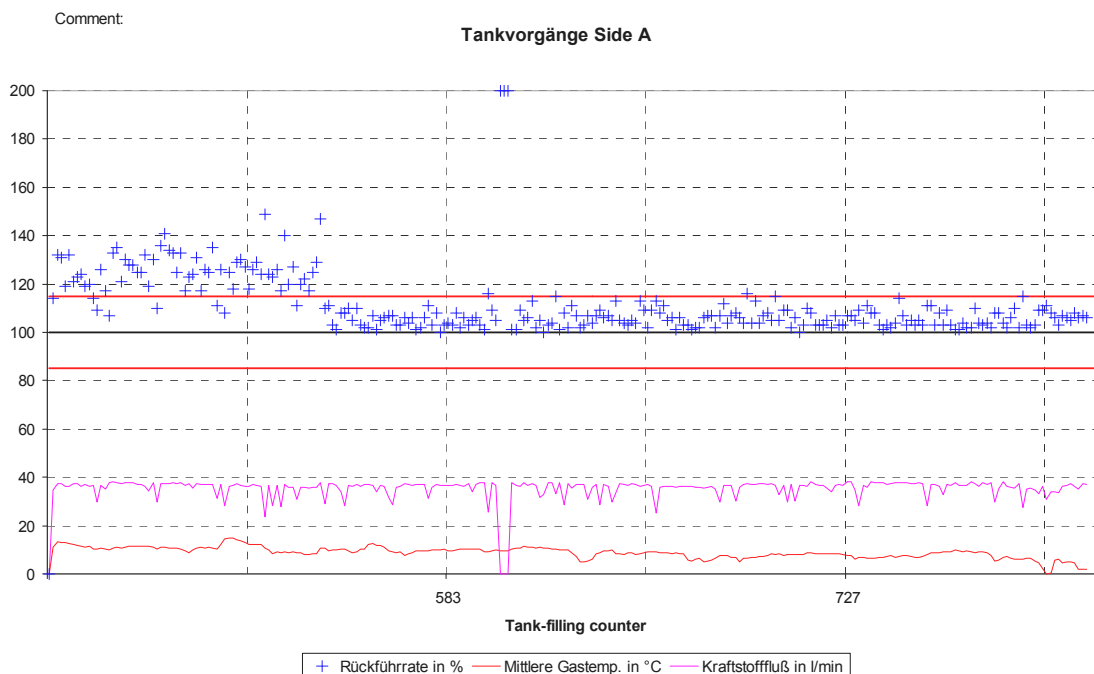
4. In the case of diaphragm or piston pumps with speed control, the pulsation is reaches the VAPORIX-Flow system in undamped form. This is why a pulsation damper should be installed between the sensor and pump. Approx. ten times the displacement volume of the pump or 200 cm³ should therefore be used as a typical reference value. Pulsation dampers are available from FAFNIR.

Figure 20: Speed-controlled vapour recovery system with diaphragm pump and too short pipe connection between VAPORIX-Flow and the pump. During refuelling operation 520, a pulsation damper was installed. The recovery rates and the spread of the measurement values decreased considerably.

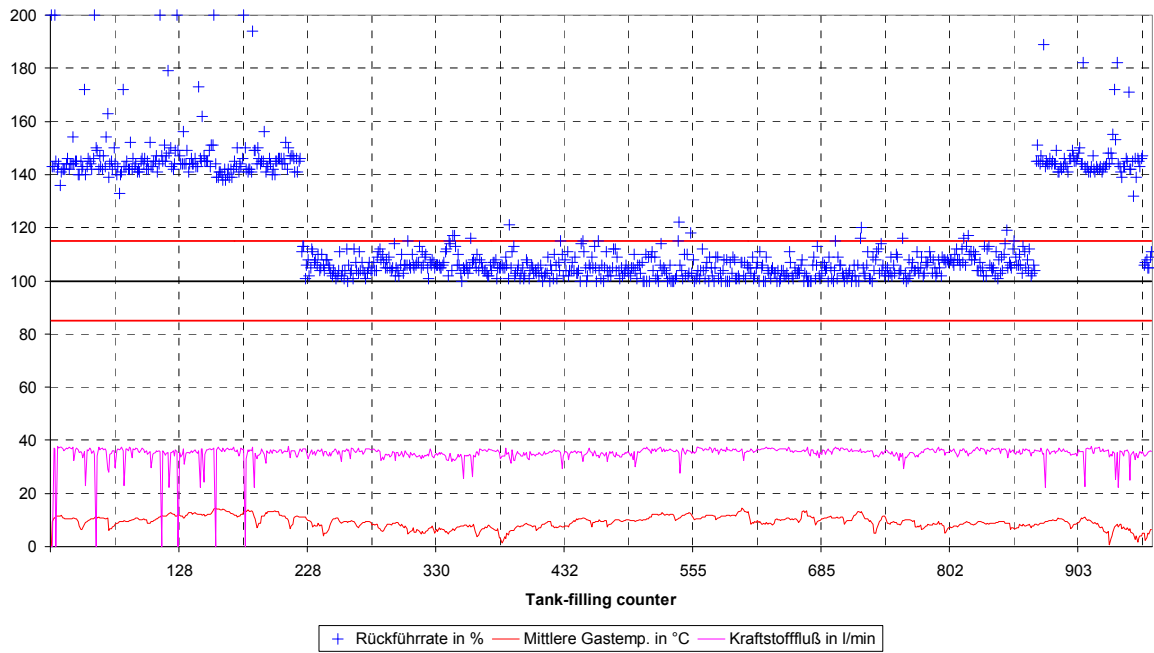
5. In the case of diaphragm or piston pumps with a liquid-controlled valve in the nozzle, the pulsation of the pump running at full speed pulsation also has a direct effect on the VAPORIX-Flow system. Here the same measure should be provided, as described in item 4.

Figure 21: Case with a liquid-controlled valve in the nozzle. During refuelling operation 224, a pulsation damper was installed. Refuelling operations 871...954 were carried out again without a pulsation damper.
