VAPORIX Diagnostics Summary

Documentation
for facilitating the troubleshooting procedure
in vapour recovery systems at filling stations
equipped with an automatic monitoring system of the type
VAPORIX.

Edition: 2016-10
Version: 1
Art. no.: 207155

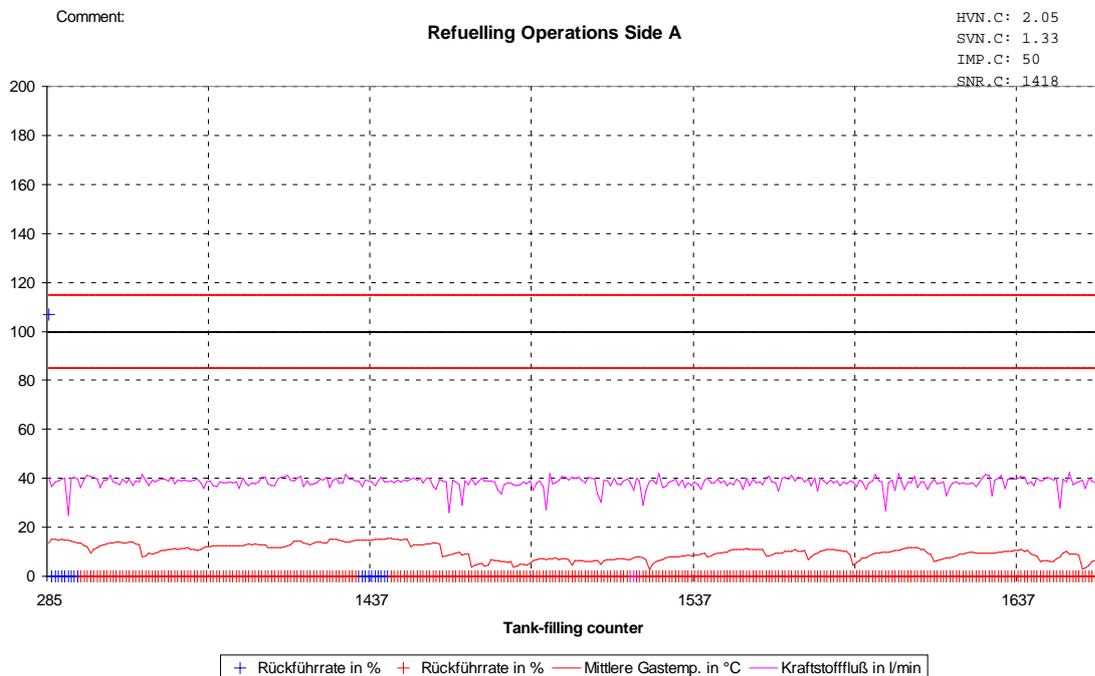
- Pump defective
- Thermal circuit breaker of the pump has tripped
- V-belt torn or jumped off

- Vapour recovery rate is very low or equal to zero as shown in Figure 4.

Figure 4: Total failure in the vapour recovery with 0% recovery rate. The colour of the crosses changes from blue to red as soon as the error counter reaches the value 10. At refuelling operation number 1433 a reset was exerted but without repairing the system. Therefore the colour of the crosses were blue for ten refuellings and then change to red again.

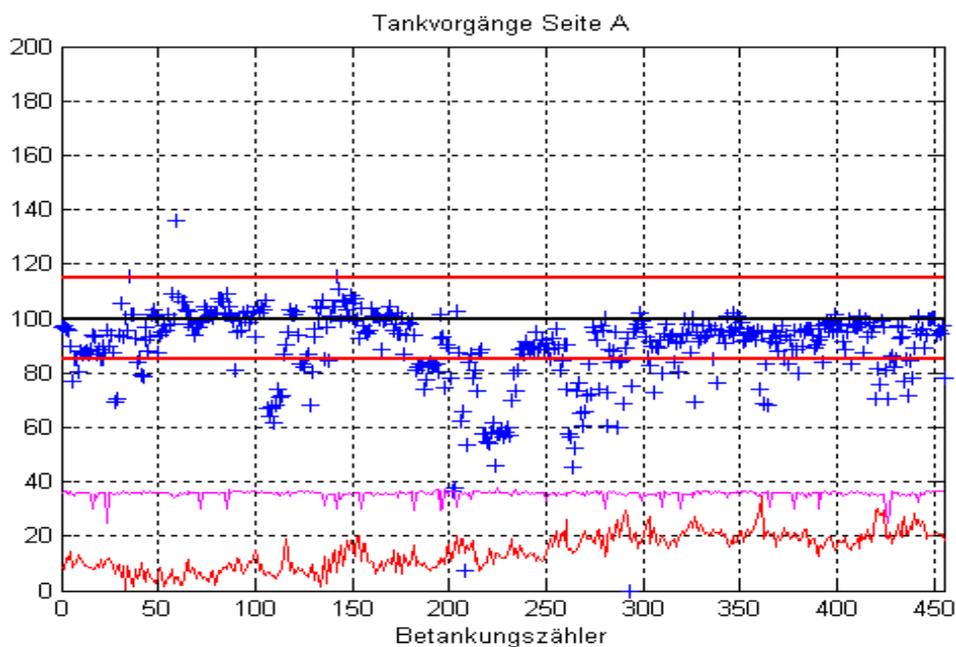
- Metal chips or other dirt particles in the proportional valve
- Wear

In some cases, a balancing operation can still be carried out despite the fault. However, the adjustment curves created as a result are incorrect. The measured recovery rates vary considerably and can be much too high or much too low. In case the defect did not occur until after the adjustment procedure, the history data will be as shown in Figure 5.

Figure 5: Dispenser point with sticking proportional valve. The x axis represents the refuelling counter, the blue crosses the recovery rate in percent, red line the gas temperature and the magenta line the average fuel flow speed.

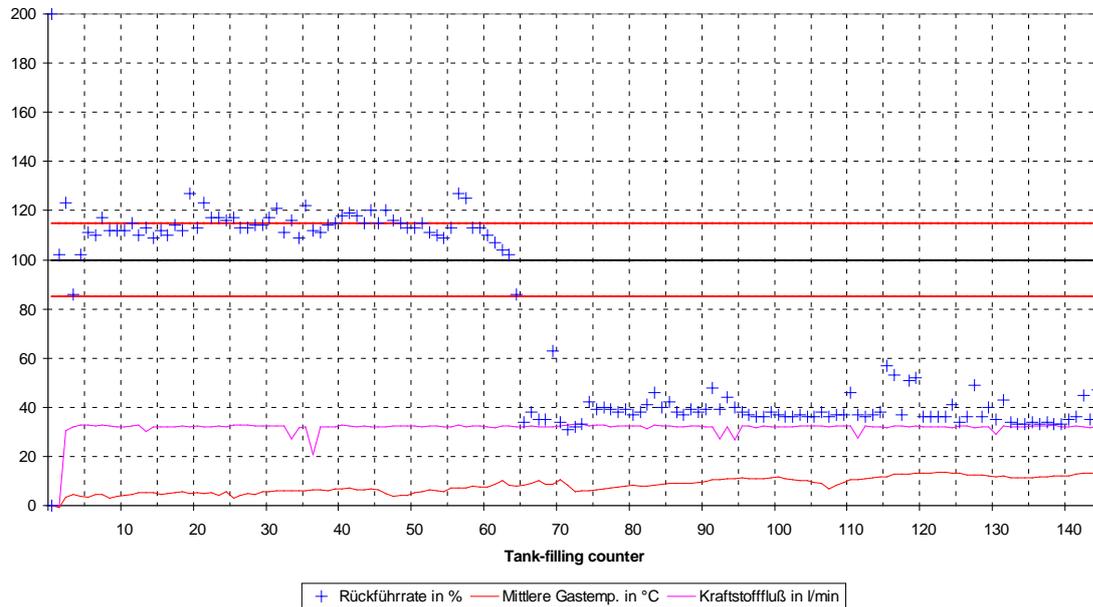
- 1) A leak (e.g. crack in the pipe or loose screw joint) occurs downstream from the sensor of the automatic monitoring system, in a time after the vapour recovery system was correctly adjusted without any leaks. In that case, the measurement value of the automatic monitoring system drops as shown in Figure 6. A dry measurement with a diaphragm flow meter at the nozzle would exhibit the same result.

Figure 6: Example according to case 1. Refuelling history of a refuelling point, which during refuelling operation 65, a crack occurred in the flexible corrugated pipe between the sensor of the automatic monitoring system and the vapour pump. Due to the suction of additional air, the recovery rate fell to approx. 40 %.

- Leak test and sealing of the respective locations

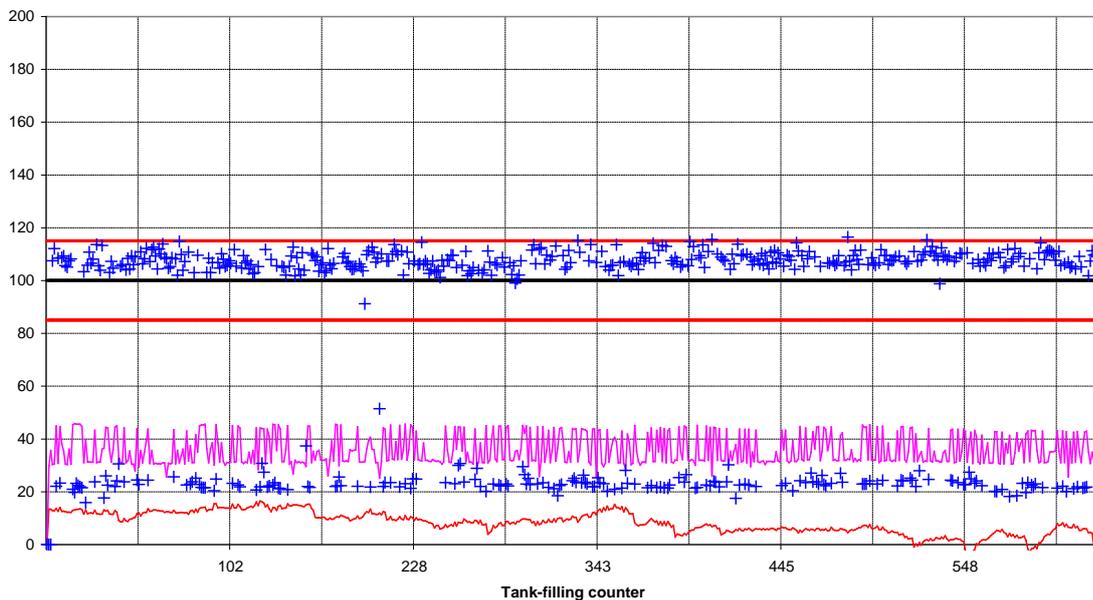
1. The defect did not already exist during the dry balancing operation of the vapour recovery or the balancing operation was carried out on a properly open nozzle. The recovery rates measured by the automatic monitoring system after the defect occurred are reduced for this hose. A dry simulation on defect nozzle would also show a reduced vapour flow. In Figure 7 is shown that the recovery rate is within the tolerance for the correct working hoses, but a reduced recovery rate is observed for the affected hose.

Figure 7: MPD with one incompletely opening Open/Close valve. Some of the refuelling operations exhibit a recovery rate of only 25%.

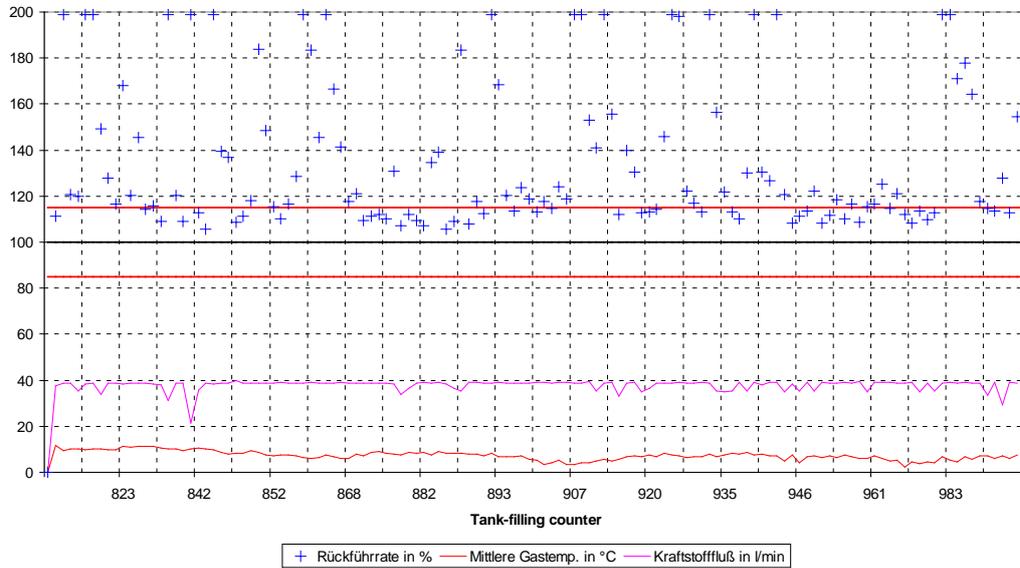
- O-rings or hoses leaky
- The fuel flow speed is too high
- Shutdown speed of the nozzle is too slow
- Unfavourably shaped fuel tank filler neck geometries of individual vehicle types
- The outlet pipe of the nozzle can be deformed as a result of falling down or a vehicle driving off

Figure 8: Occurrence of condensate in the recovery tubing. The recovery rate is frequently approximately up to 199%, which is the maximum value for the output in the case of existing pulses, as opposed to 200% in the case of non-existing pulses.

- The system should not be readjusted as long as liquid is still in the tubing since otherwise – especially in the case of vapour recovery systems with a high k-factor – the recovery rate will be too high.
- Installation of new seals
- In the case of new dispensers or new seals, wait a few days until the sealing have swollen up.
- Replacing the hoses, if the cause cannot be found elsewhere
- Reduction of the fuel flow speed to values ≤ 40 l/min
- Replacing the nozzle by one with a more sensitive switch-off characteristic, if necessary, adjustment of the sensitivity
- Replacing the outlet pipe of the nozzles

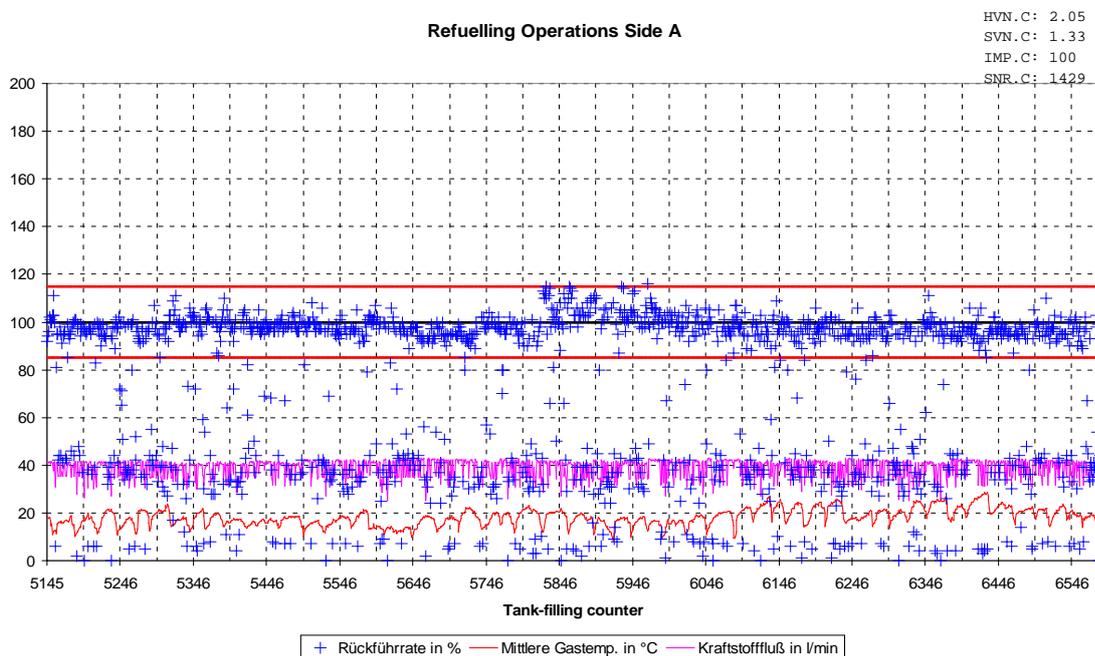
- Random values from before are then used for the control system. The recovery rates can be far apart depending on the fuel flow rate in each case (see Figure 9).
- A dry measurement reproduces the measurement values of the automatic monitoring system.
- Perform dry measurements with a diaphragm flow meter for different pump flow speeds.
- In order to detect possible causes sort the data with respect to the fuel flow speed. The result is shown in figure 10. It reveals immediately that the recovery rate is strongly dependent on the fuel flow speed. This indicates a faulty adjustment of the vapour recovery system.

Figure 9: Data of dispenser point with frequently extremely reduced recovery rate. The exact cause cannot be detected in the standard data representation.

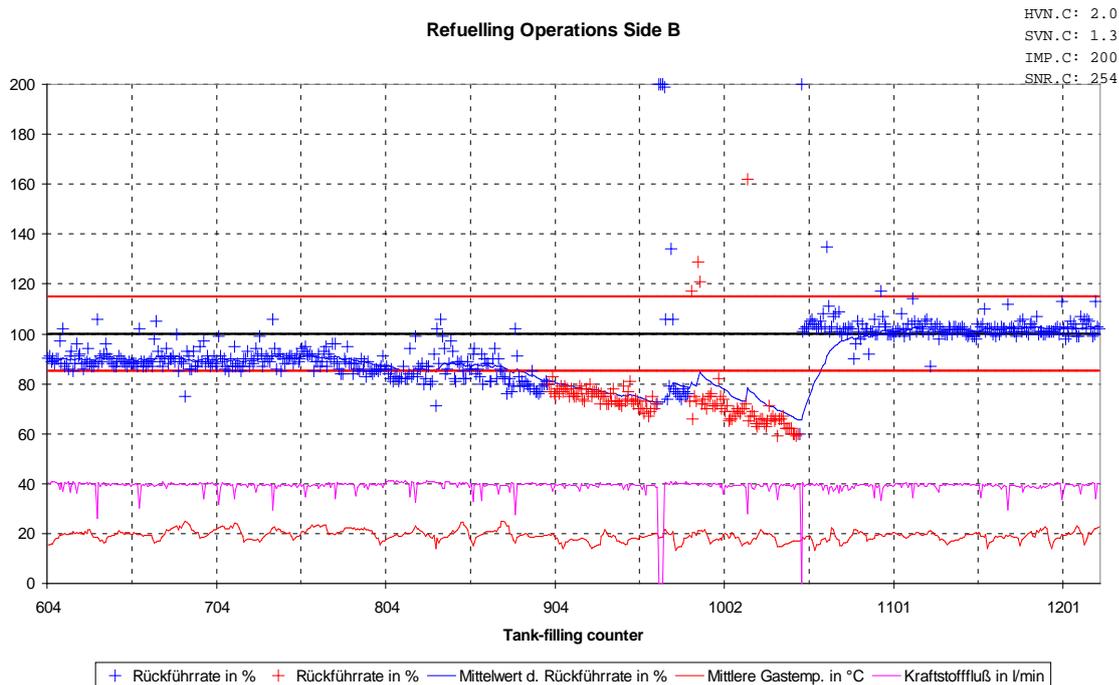
- Due to the advanced wear of the vapour pump, the pumping performance decreases more and more.

- The recovery rate drops more and more.
- Balancing operations provide only short-term improvement or no improvement at all.
- Dry measurements with a diaphragm flow meter show the same result.

Figure 11: The recovery rate of the vapour recovery decreases more and more with time. The readjustment procedure at refuelling operation #965 only provides slight improvement. Replacing the pump during refuelling operation #1046 finally eliminates the cause.

- Repair or replace the vapour pump

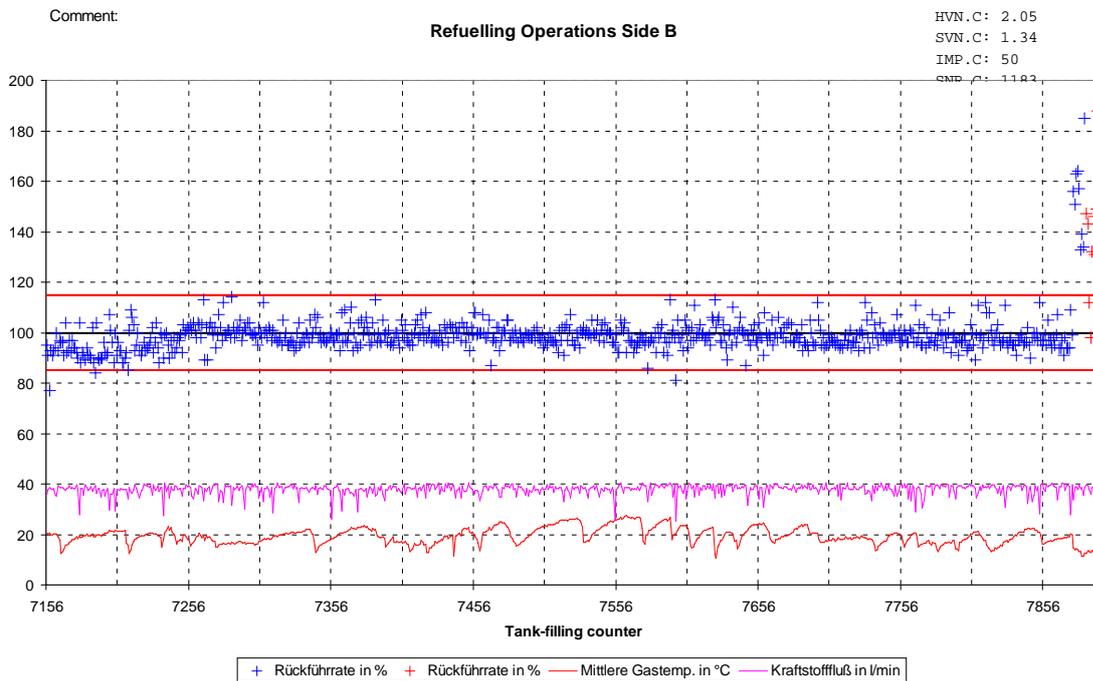
- When attempting to leave the filling station without removing the nozzle from the fuel tank filler neck of the vehicle, the nozzle and/or the hose might be damaged. In the example shown in Figure 12, only the nozzle was replaced/repared but a tear in the hose remained undiscovered, and therefore VAPORIX triggered an alarm after the dispenser was put into service again.

- The diagnosis can be made more difficult because no information about the previous repair work is available at the time of the VAPORIX alarm rectification. In Table 2, it can only be seen that the dispenser point was shutdown for about one day.
- The recovery rate shown in Figure 12 apparently increases suddenly in the case of a previously perfect dispenser point.

- The status bit for liquid recovery (10-0000) has been set.

Figure 12: The recovery rate of the vapour recovery increases suddenly and apparently uncontrolled during refuelling operation #7877.

- Replace all the adversely affected components.

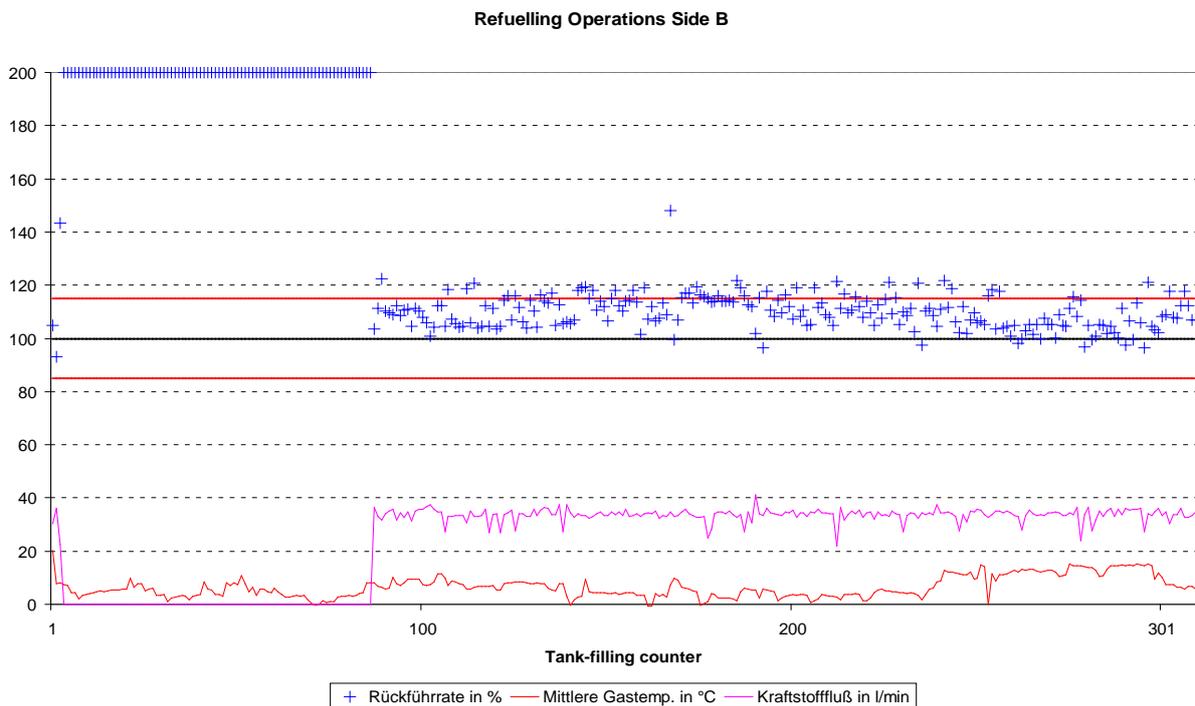
- In the course of connecting the pulse inputs, the polarity was connected incorrectly and this is why the fuel flow speed cannot be determined by VAPORIX-Control.
- By flashing very quickly, the LED on VAPORIX-Control indicates vapour flow without pulses.
- Refuelling operations with vapour flow without pulses are included in the history data; the vapour pumping rate is indicated with 200%.

Figure 13: The connecting cable for the fuel pulses is not correctly attached on the VAPORIX-Control system, the output recovery rate is indicated to 200 % and the fuel flow speed is 0 l/min. During refuelling operation 87, the connection fault was rectified.

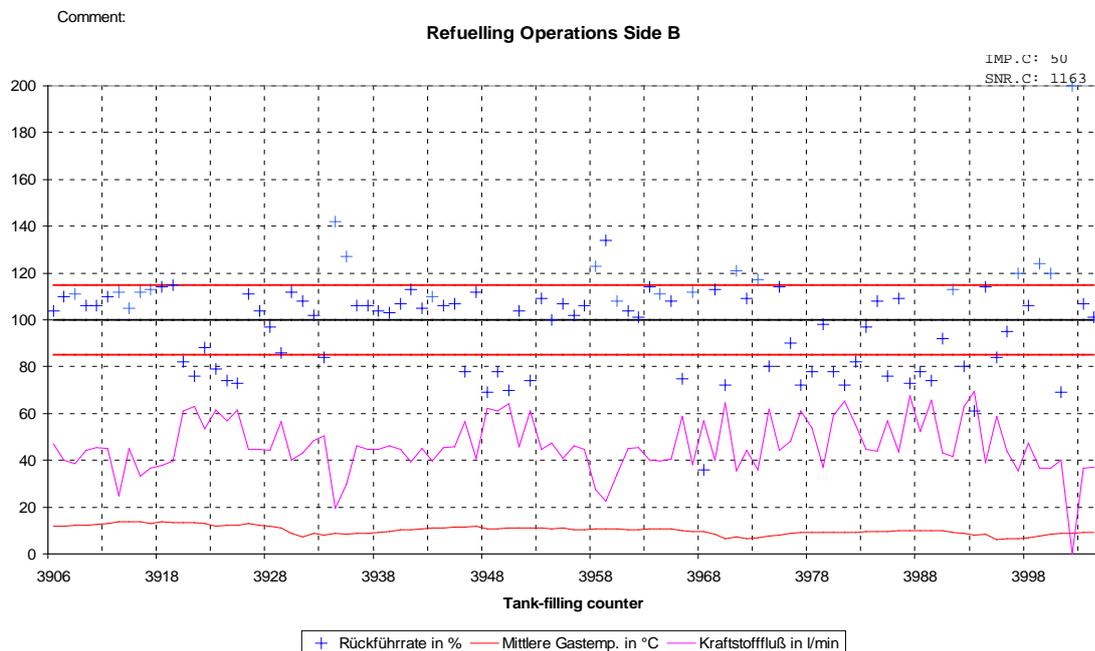
- Extreme interference couples into the pulse cables, which causes to an increased pulse rate at the inputs of the VAPORIX-Control. Accordingly, the evaluated fuel flow speed appeared too high and the recovery rate too low.

Figure 14: The output fuel pumping rate is partially above 60 l/min and exhibits an unusual scatter.

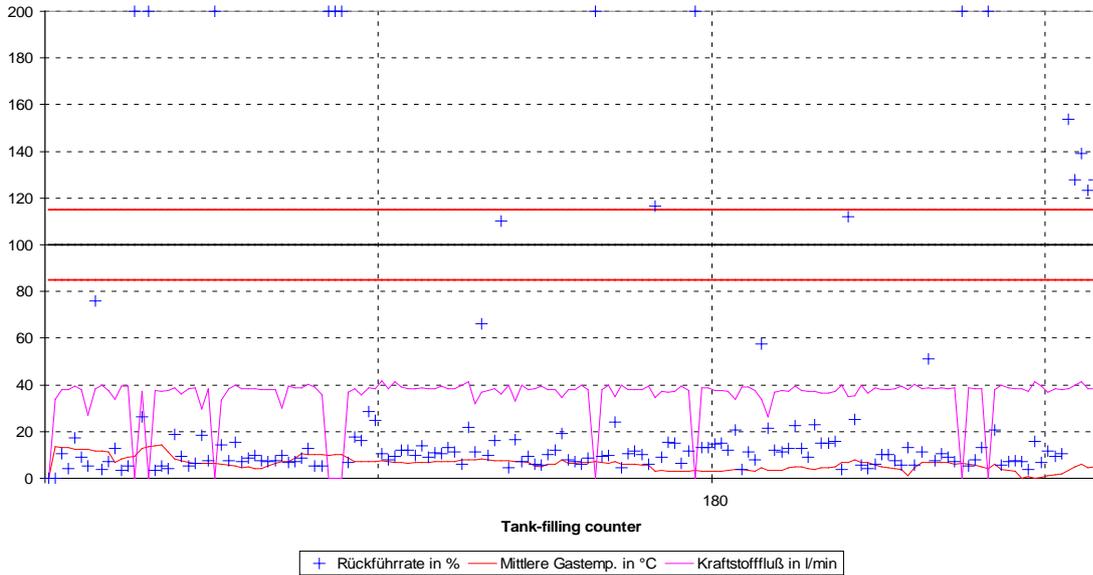
Figure 15: Refuelling operation on side A of an MPD with opposite-side control of the vapour recovery. The apparent recovery rate of approx. 10% is caused by pulsation of the vapour recovery system running on the other side.

Table 4: The history entries from figure 15 with recovery rates greater than 50%. By comparing the date and time (e.g. 16:22 on 8.11.) with the entries of side B shown in Table 5 it can be seen that these recovery rates frequently occur during simultaneous refuelling operations on both sides. If the respective refuelling operation on the other side is missing, it took only a short period of time (< 20 sec) and was therefore not included in the history.

- Exchanging the control cables of the vapour recovery system

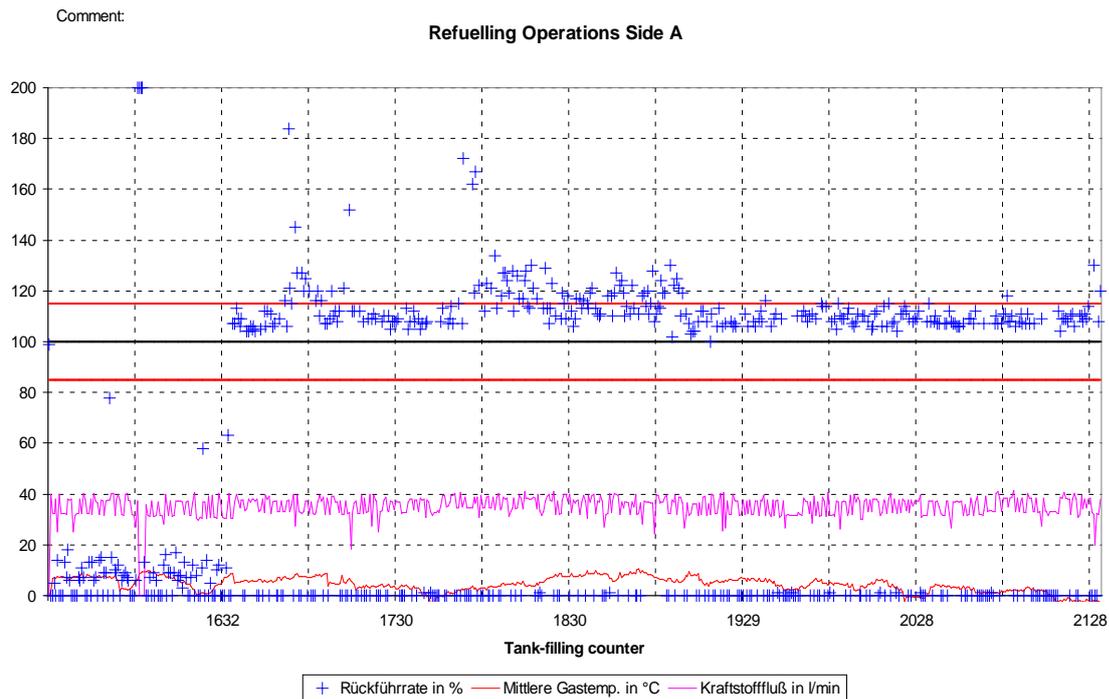
Figure 16: The same dispenser point as shown in after exchanging the cables of the vapour recovery system. During refuelling operation 1890, the system was adjusted. The pulses representing diesel refuellings are still present.

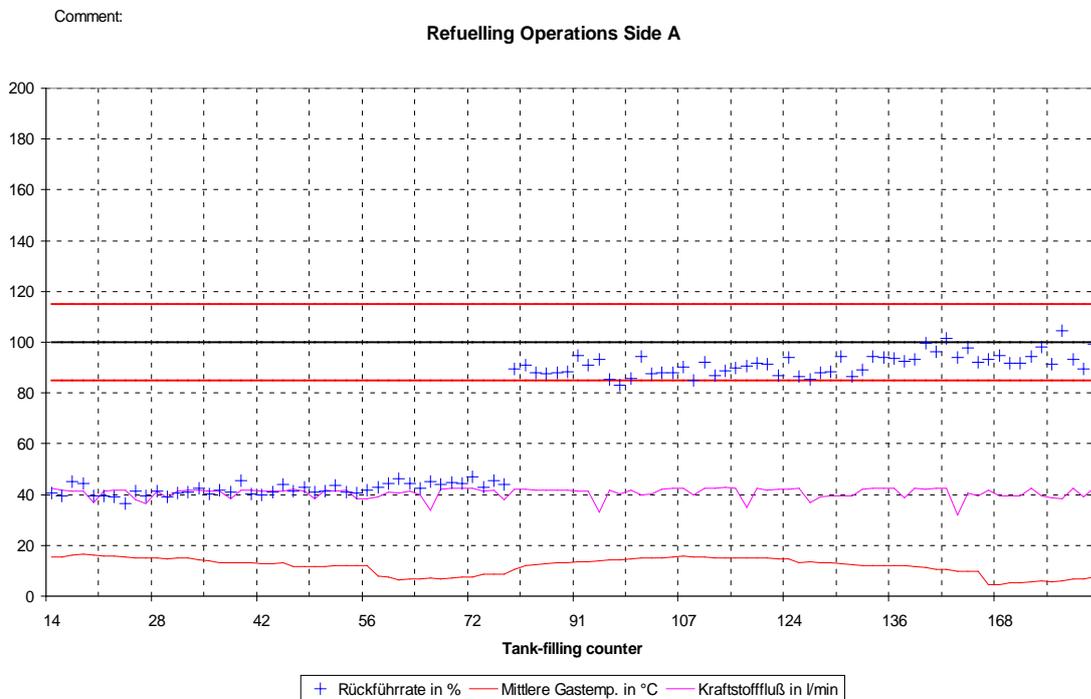
- If the impulse rate is set too high in the vapour recovery control system, the volumetric flow of fuel will be interpreted too low and the vapour recovery system will not be pumping enough. A wet measurement with a diaphragm flow meter would also provide values that are too low. A dry measurement would provide apparently correct values.

Figure 18: The refuelling operations 14...75 were carried out at an impulse rate set too high for the vapour recovery system. As a result, the vapour recovery ran with only half the pumping performance.

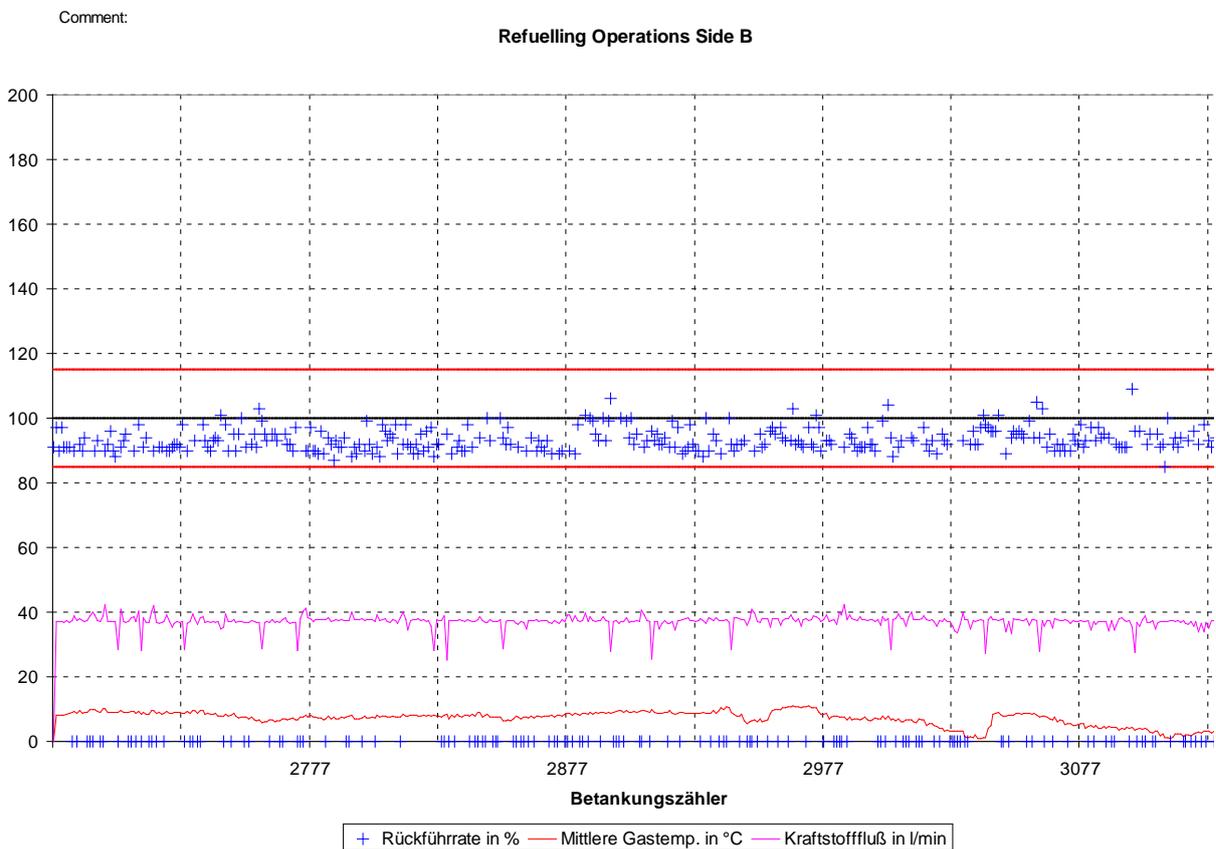
- Faulty configuration of the dispenser or missing interface for inhibiting the diesel pulses

- The diesel refuelling operations appear in the history data. If the vapour recovery is not running simultaneously, it is equal to zero, but if it is running, this can result in a small measurement value. The probability for the occurrence of these refuelling operations is approx. 30%. An alarm would be triggered only if 10 diesel tank-filling operations were to occur in succession.

Figure 19: Diesel pulses are not hidden. In case more than 10 diesel tank-filling operations are carried out in succession, an alarm is triggered.

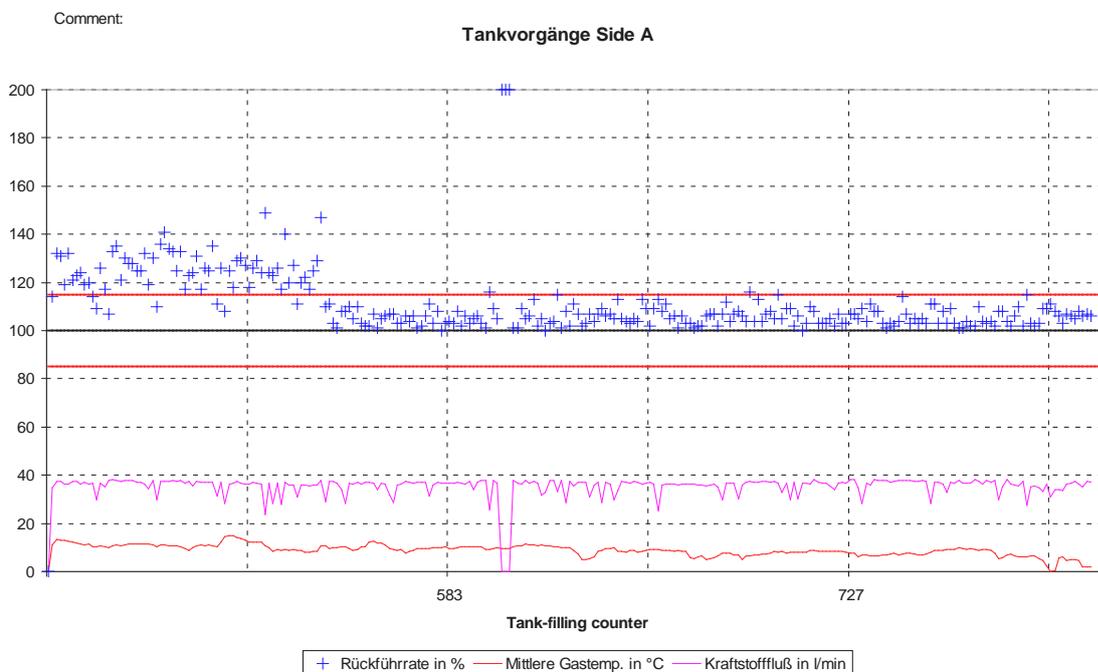
4. In the case of diaphragm or piston pumps with speed control, the pulsation reaches the VAPORIX-Flow system in undamped form. This is why a pulsation damper should be installed between the sensor and pump. Approx. ten times the displacement volume of the pump or 200 cm^3 should therefore be used as a typical reference value. Pulsation dampers are available from FAFNIR.

Figure 20: Speed-controlled vapour recovery system with diaphragm pump and too short pipe connection between VAPORIX-Flow and the pump. During refuelling operation 520, a pulsation damper was installed. The recovery rates and the spread of the measurement values decreased considerably.

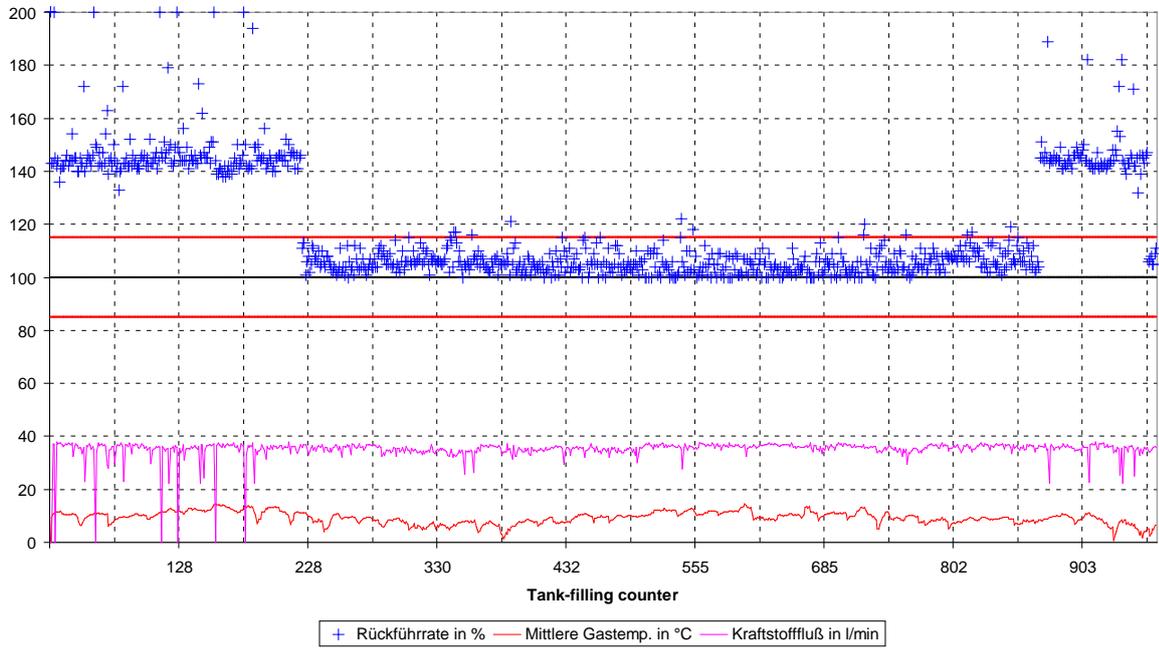
5. In the case of diaphragm or piston pumps with a liquid-controlled valve in the nozzle, the pulsation of the pump running at full speed pulsation also has a direct effect on the VAPORIX-Flow system. Here the same measure should be provided, as described in item 4.

Figure 21: Case with a liquid-controlled valve in the nozzle. During refuelling operation 224, a pulsation damper was installed. Refuelling operations 871...954 were carried out again without a pulsation damper.
